# **Debris/Ice/TPS Assessment and Integrated Photographic Analysis of Shuttle Mission STS-83**

*Process Engineering/Mechanical System Division/ET-SRB Branch,  
Kennedy Space Center, Florida*

**DEBRIS/ICE/TPS ASSESSMENT  
AND  
INTEGRATED PHOTOGRAPHIC ANALYSIS  
OF  
SHUTTLE MISSION STS-83**

**4 April 1997**

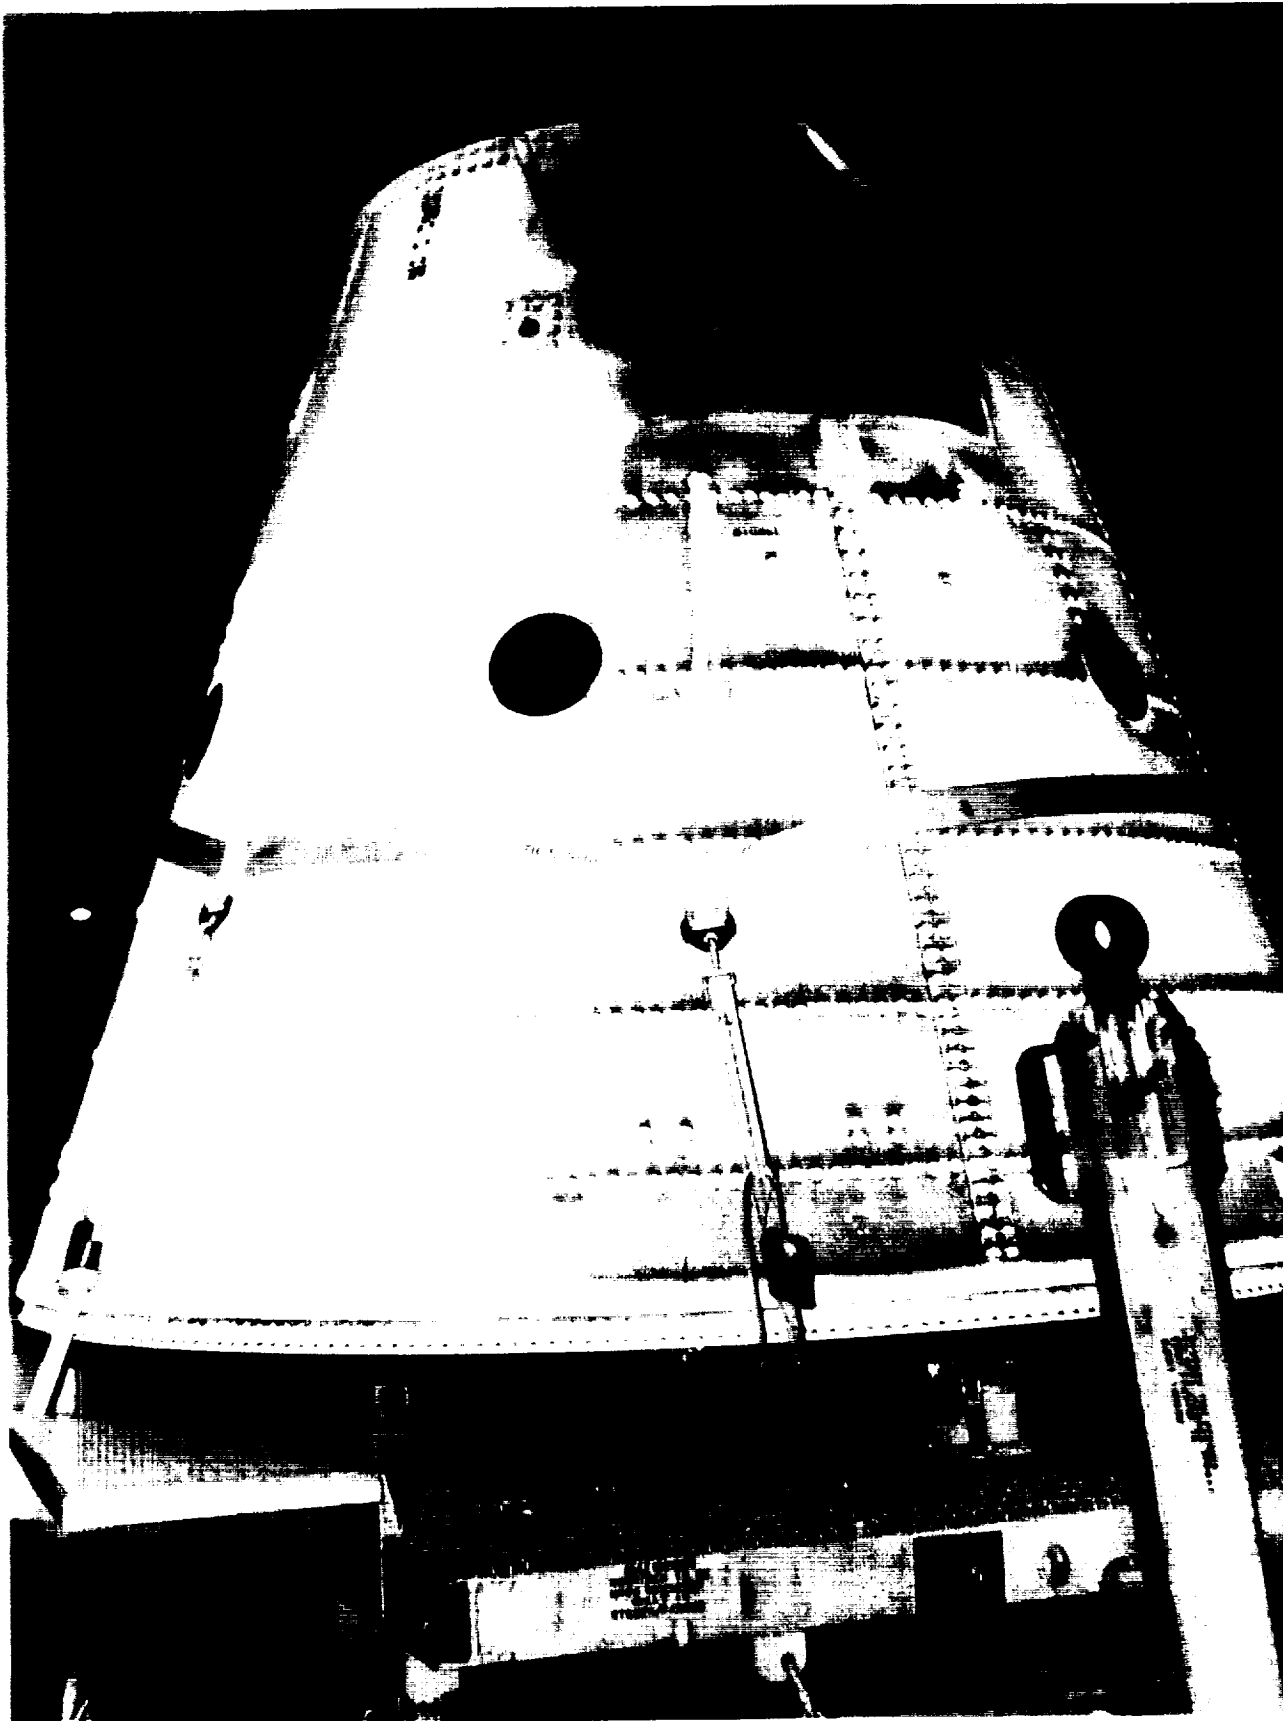
**Photo 15: Left Frustum**

The left frustum was in excellent condition. No TPS was missing and no debonds were detected over fasteners or acreage. None of the Hypalon paint had blistered. All four BSM aero heat shield covers appeared to be locked in the fully opened position

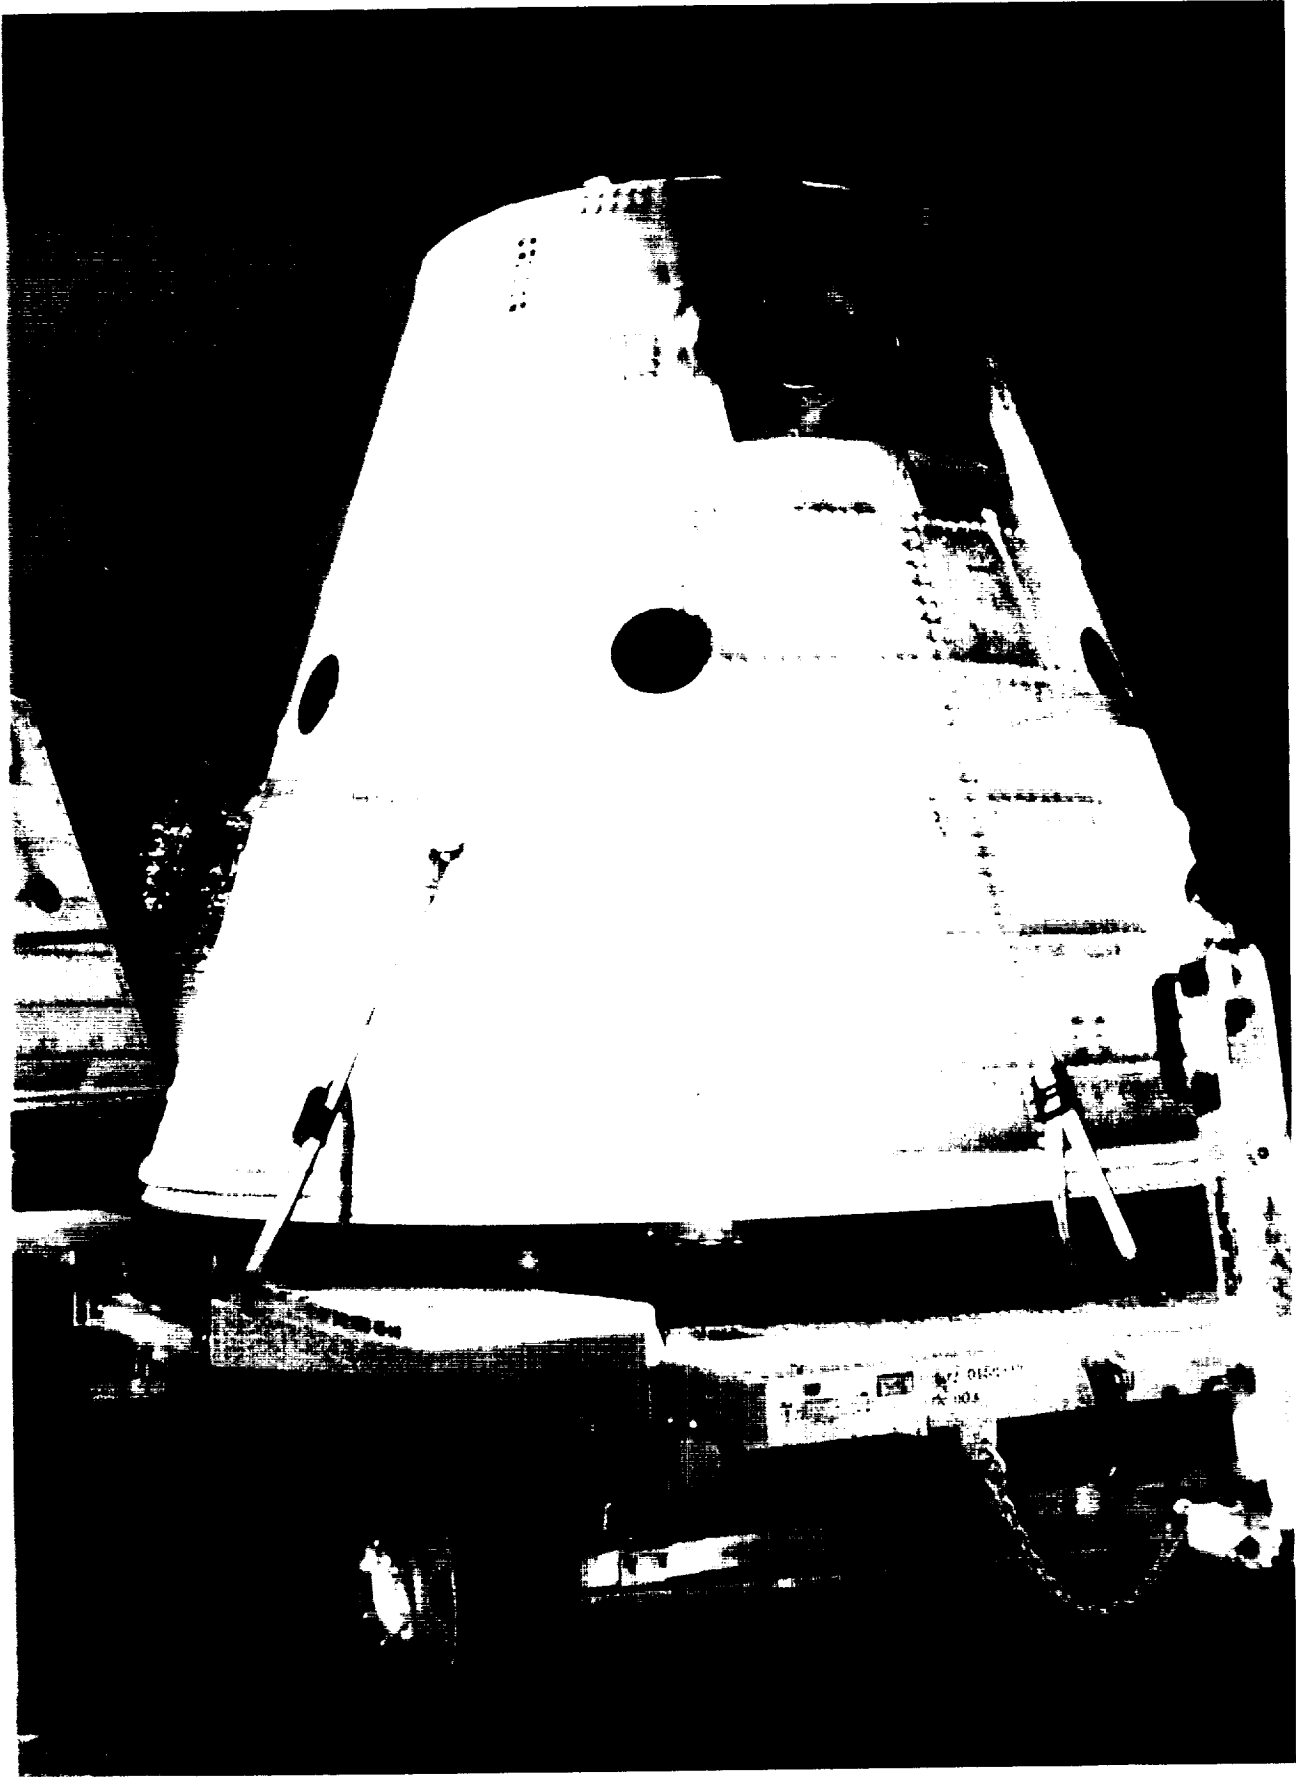
**Photo 16: Right Frustum**

The right frustum was in excellent condition. No TPS was missing and no debonds were detected over fasteners or acreage. None of the Hypalon paint had blistered.

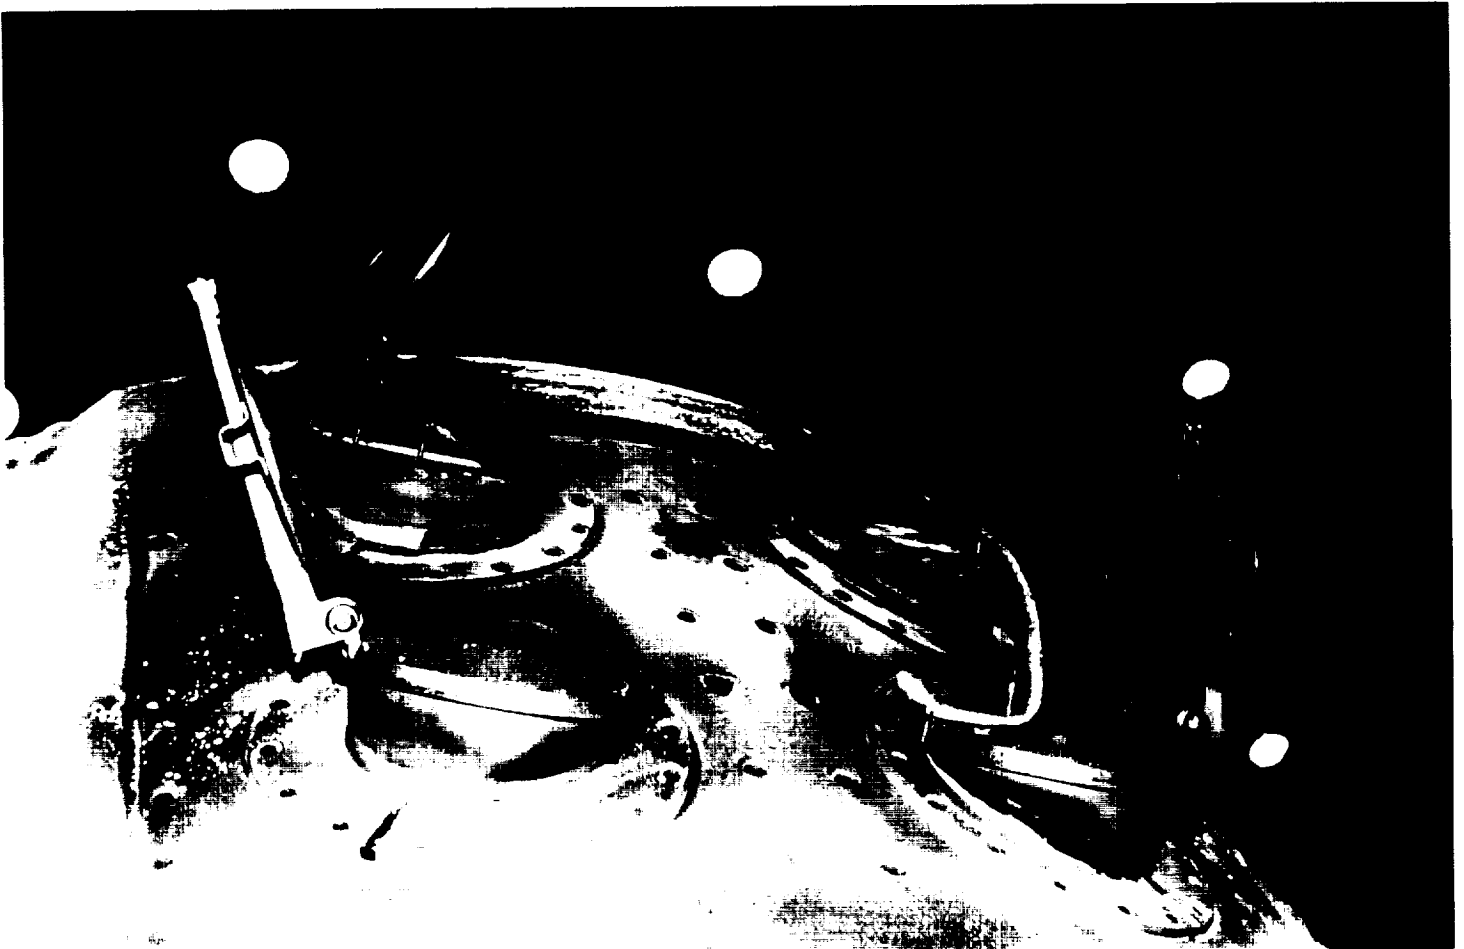
**Photo 17: Right Frustum BSM's**

All four BSM aero heat shield covers on the right frustum appeared to be locked in the fully opened position, though all four cover attach rings had been bent by parachute riser entanglement. The upper right cover was missing.

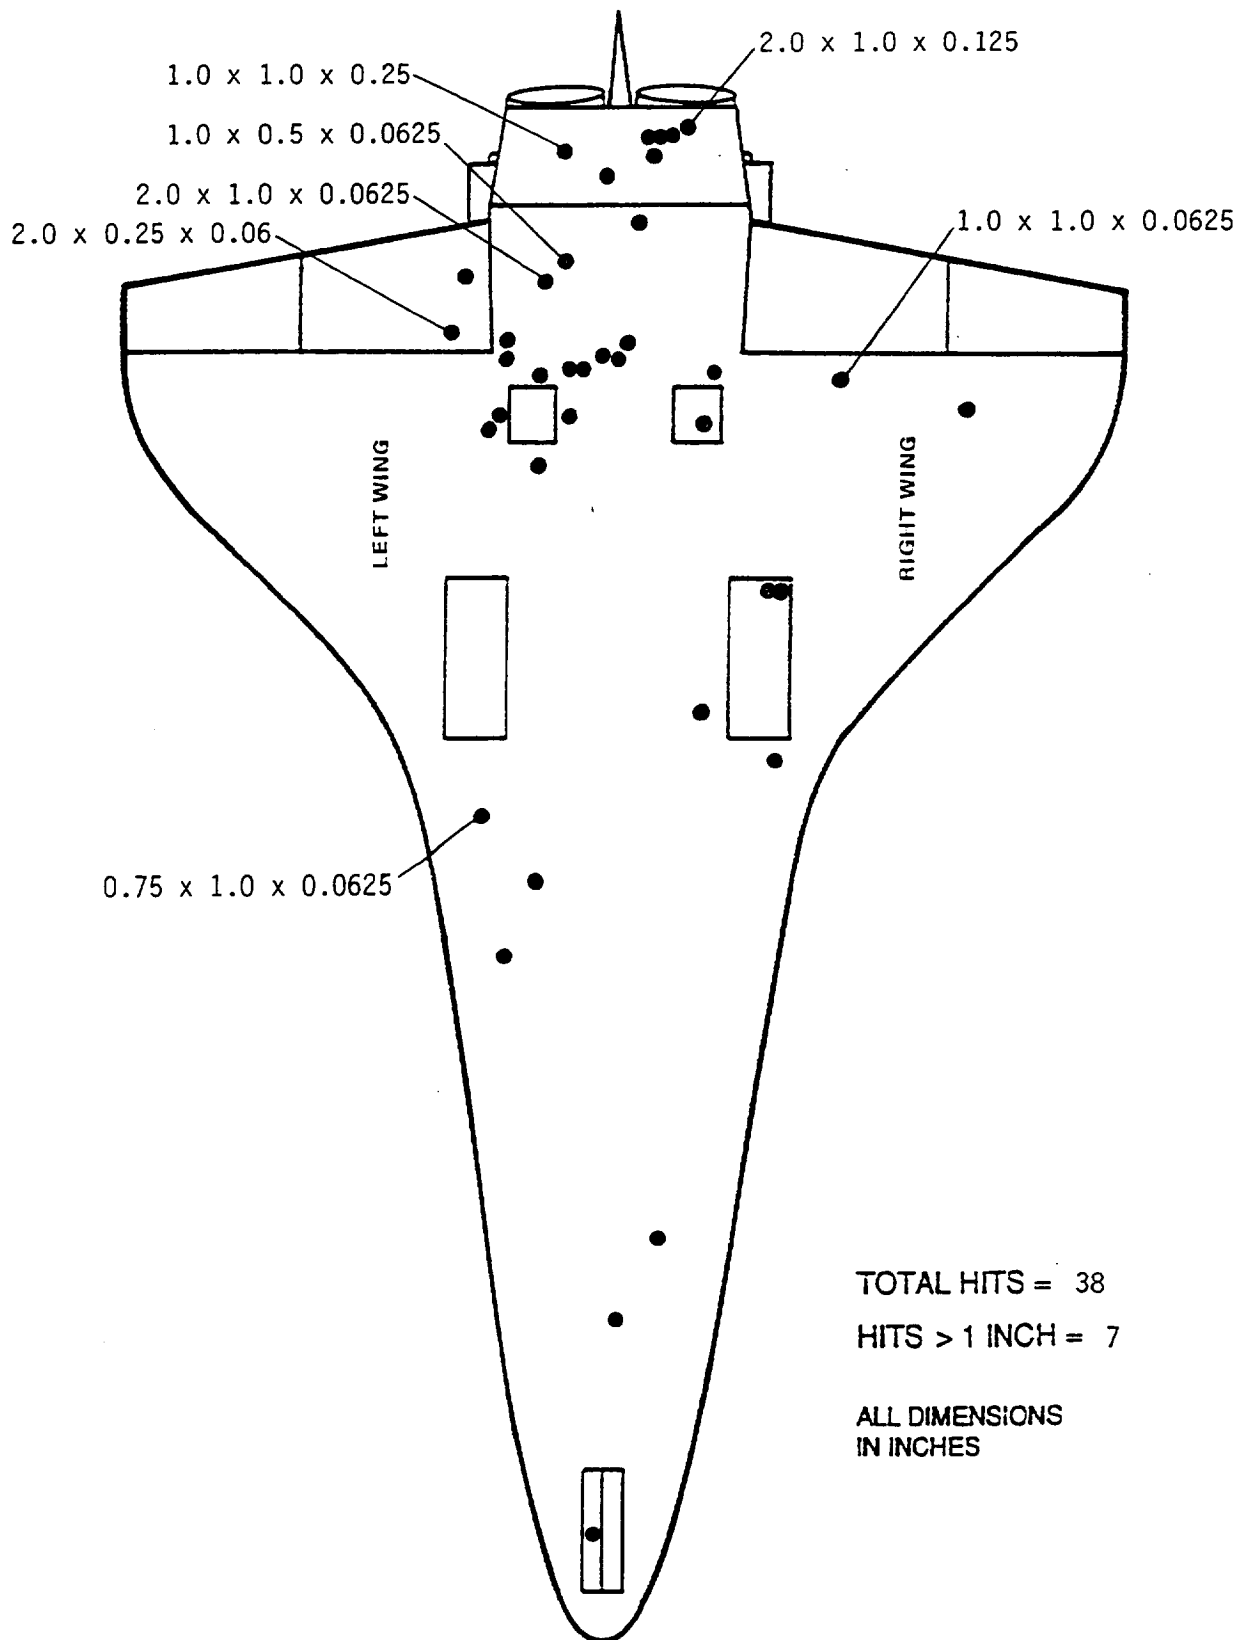
**Figure 1: Orbiter Lower Surface Debris Damage Map**

The Orbiter lower surface sustained a total of 38 hits, of which 7 had a major dimension of 1-inch or larger. The largest lower surface tile damage site was located on the body flap. The site measured 2-inches long by 1-inch wide by 0.125-inch maximum depth. The damage was probably caused by an impact from ET/ORB umbilical ice.

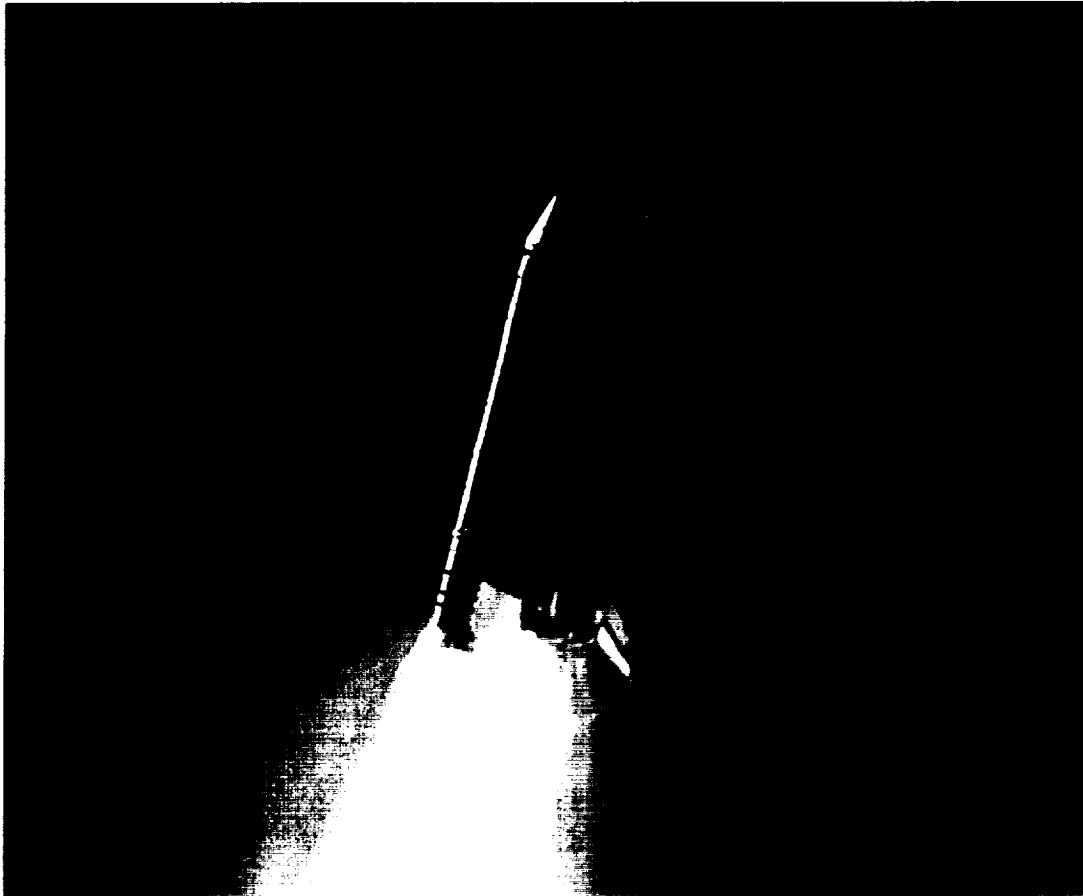
Figure 2.2 (C) Debris Aft of Vertical Stabilizer

A single piece of debris fell aft of the vertical stabilizer during ascent (19:20:49.550 UTC), (Camera E222).

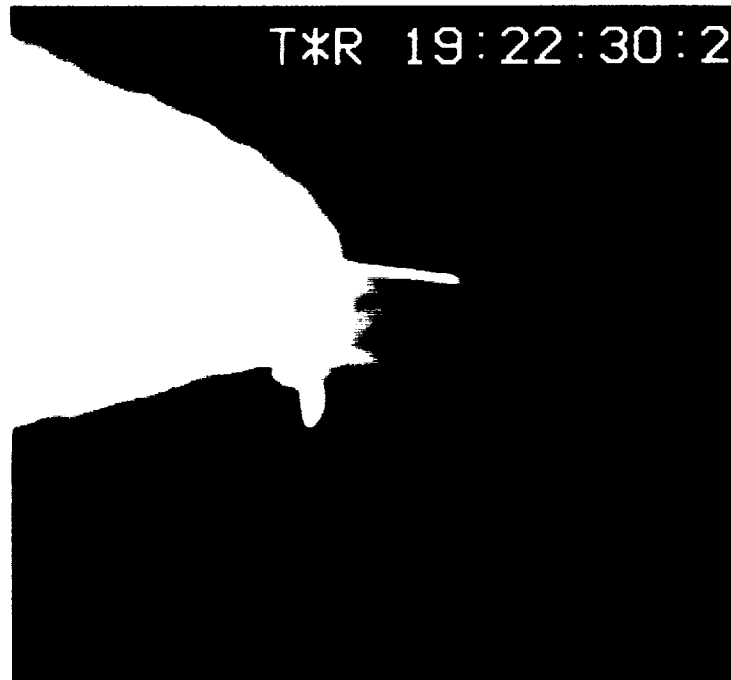
Figure 2.2 (D) Debris Near SRB Exhaust Plume During Ascent

Multiple pieces of debris (possible SRB aft skirt insta-foam) were seen falling along the SRB exhaust plume during ascent. The debris were seen at 19:20:50.433, 19:20:51.4, 19:20:53.2, 19:21:39.2, and 19:22:30.733 UTC (Cameras KTV4A, KTV13, KTV21A, ET204, ET212, E224).

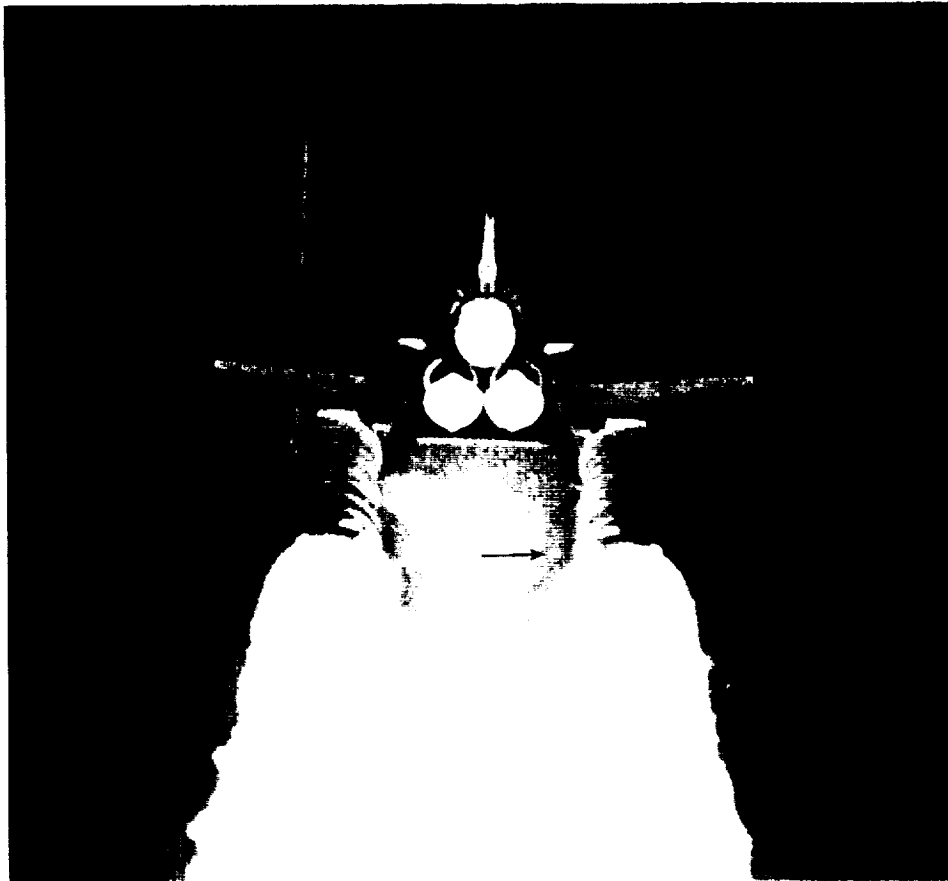
Figure 2.2 (E) Debris Near ET Dome and RSRB

Six relatively large pieces of debris (probably umbilical purge barrier material), first seen near the ET aft dome and the RSRB aft attach ring, fell between SRBs during ascent (19:20:50.604 UTC), (Cameras E52, E54).

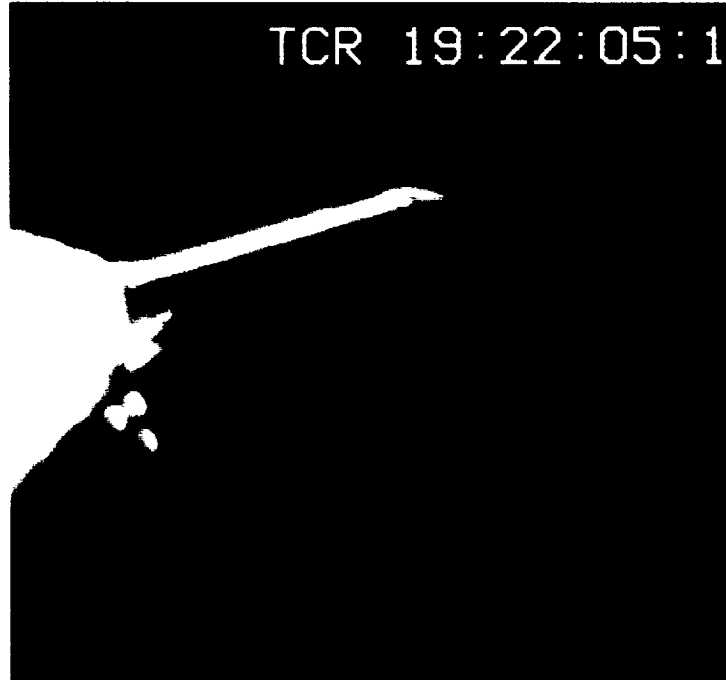
Figure 2.4 Recirculation at Aft End of Vehicle

Recirculation, or the expansion of burning gasses at the aft end of the vehicle, was seen during ascent (19:22:04.7 - 19:22:18.1 UTC). Recirculation during this time period has been seen on previous missions (Cameras KTV13, ET204, ET208, ET212, E212).
